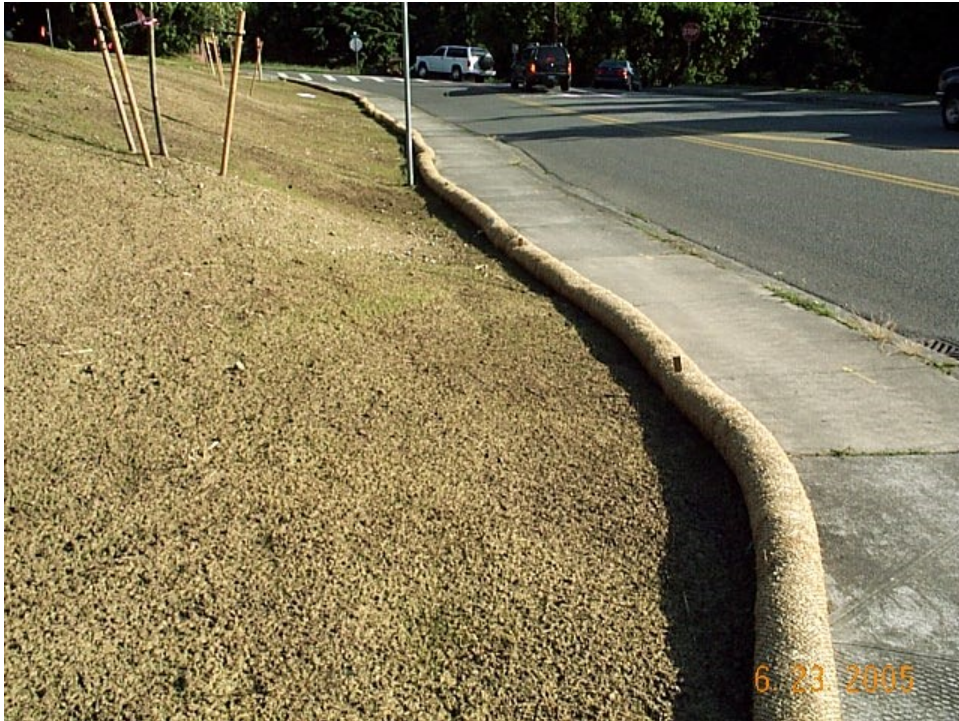
Photo 2. Example of a Shallow Gradient Slope

Example of shallow gradient slope with berm installed at downgradient edge to minimize silt-laden runoff onto the sidewalk.
